# EPA Tools & Resources Webinar: Identifying Lead Service Lines in the Community

**Simoni Triantafyllidou**

*US EPA Office of Research and Development*

**October 26, 2022**

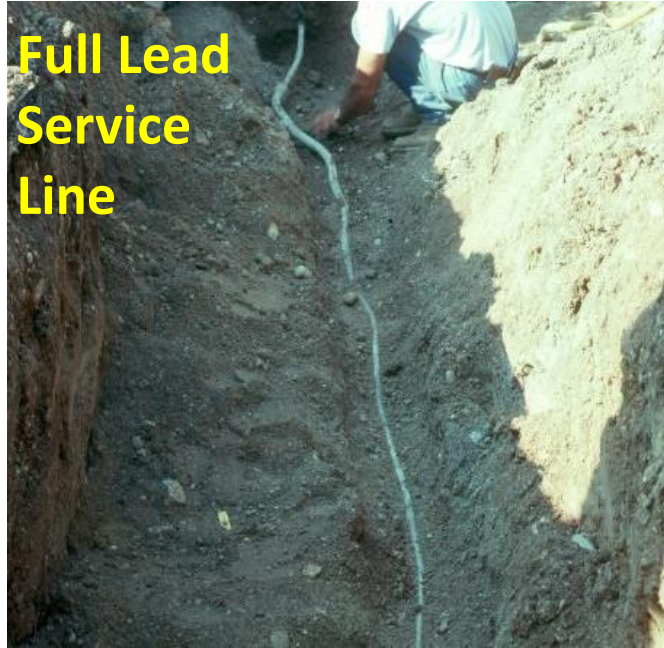
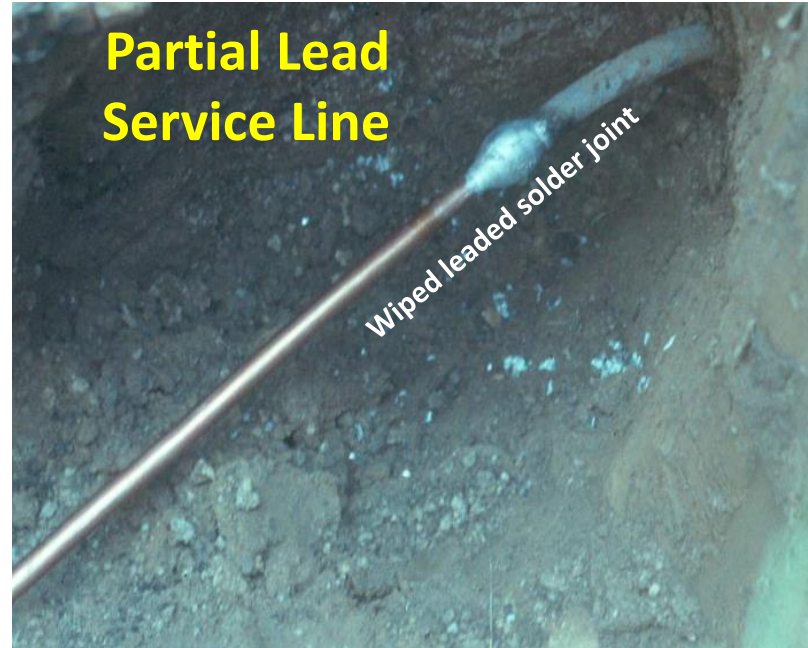
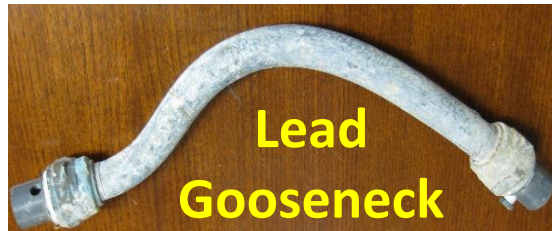
# Legacy lead and lead-lined pipes are primary contributors to water lead contamination

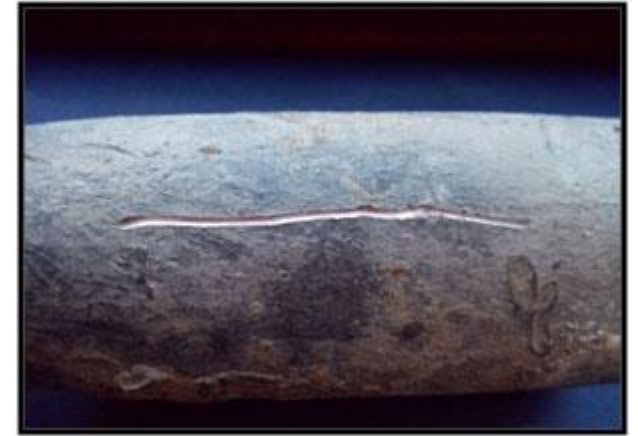
- Easy for residents if service line is accessible
- When scratched (coin, key, etc), the exposed outside pipe surface area will be shiny silver and flake off
- Magnet will not stick to Pb
- Can identify solid lead service lines but not lead-lined iron pipe

- Surface swab kits approved for lead paint change color after contacting lead surface

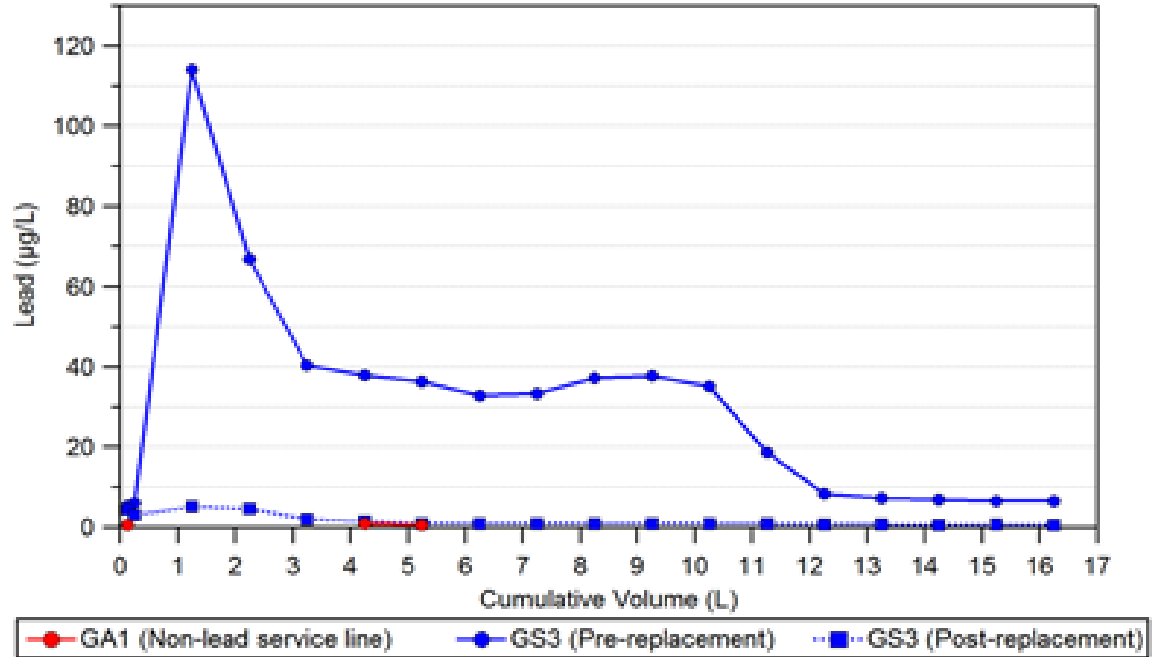
- Community-specific LSL ID water concentration thresholds needed
- High Pb “peaks” indicate likely LSL; Multi-metal analysis (e.g., Cu, Zn, Fe, Sn, Cd) helpful

## Denver Water 2019 – 6 h stagnation profiles

- LSL indicated by maximum Pb  $\geq 5 \mu\text{g/L}$  (lower Pb in water samples from homes with copper & Pb solder)
- 1/16 false negative. Confirmed LSL had Pb  $<1 \mu\text{g/L}$  in all samples (suspected lack of stagnation)

## DC Water 2019 - 6 h stagnation profiles 10x1L

- LSL indicated by total Pb mass  $\geq 5 \mu\text{g}$  and shape of profiles
- 2/30 false negatives

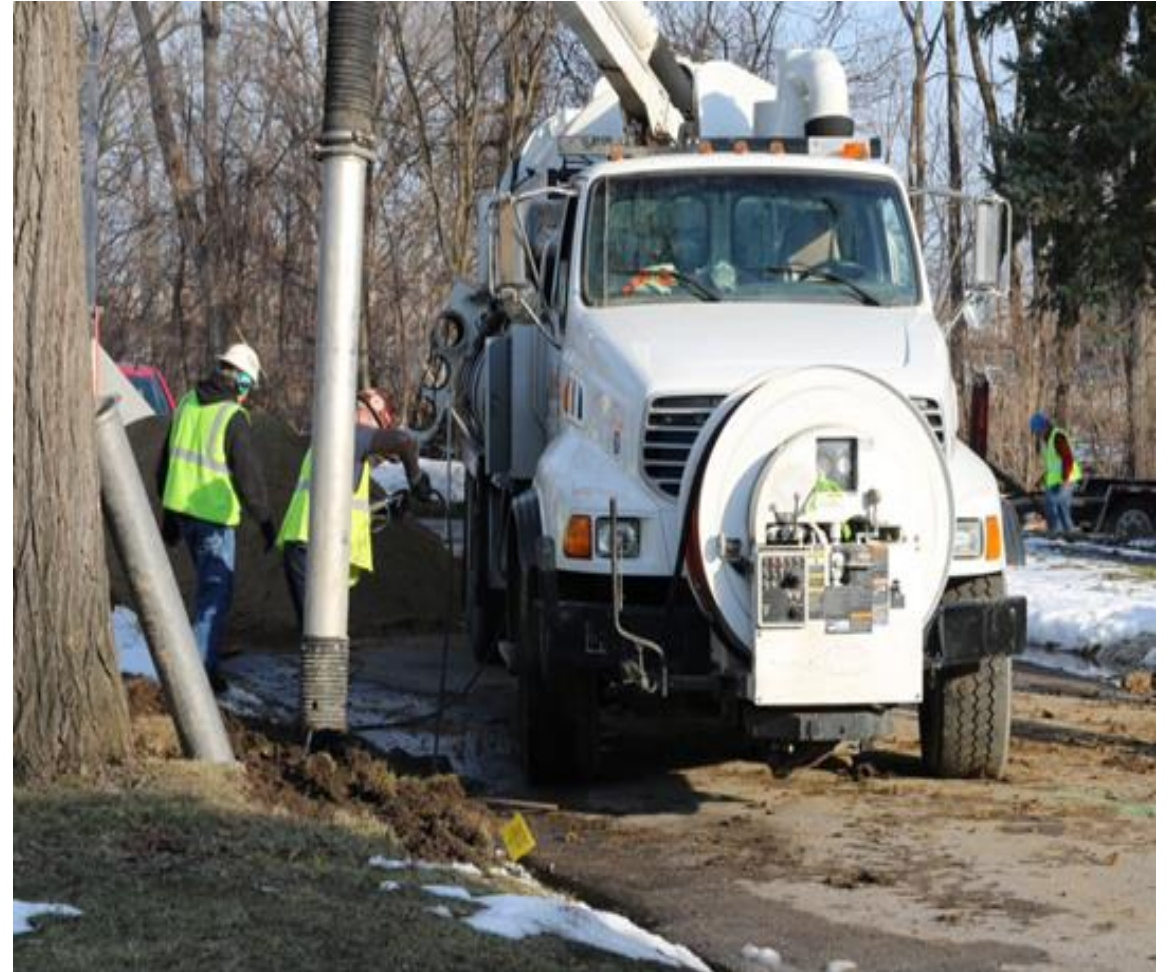
Hydro-vacuum truck consists of a high-pressure water jet and industrial vacuum. Jet loosens soil, vacuum removes it into a holding tank until the SL is exposed

- Smaller hole, less expensive, less disturbance

- Heterogeneous SL may have lead segments that could be missed by single hole

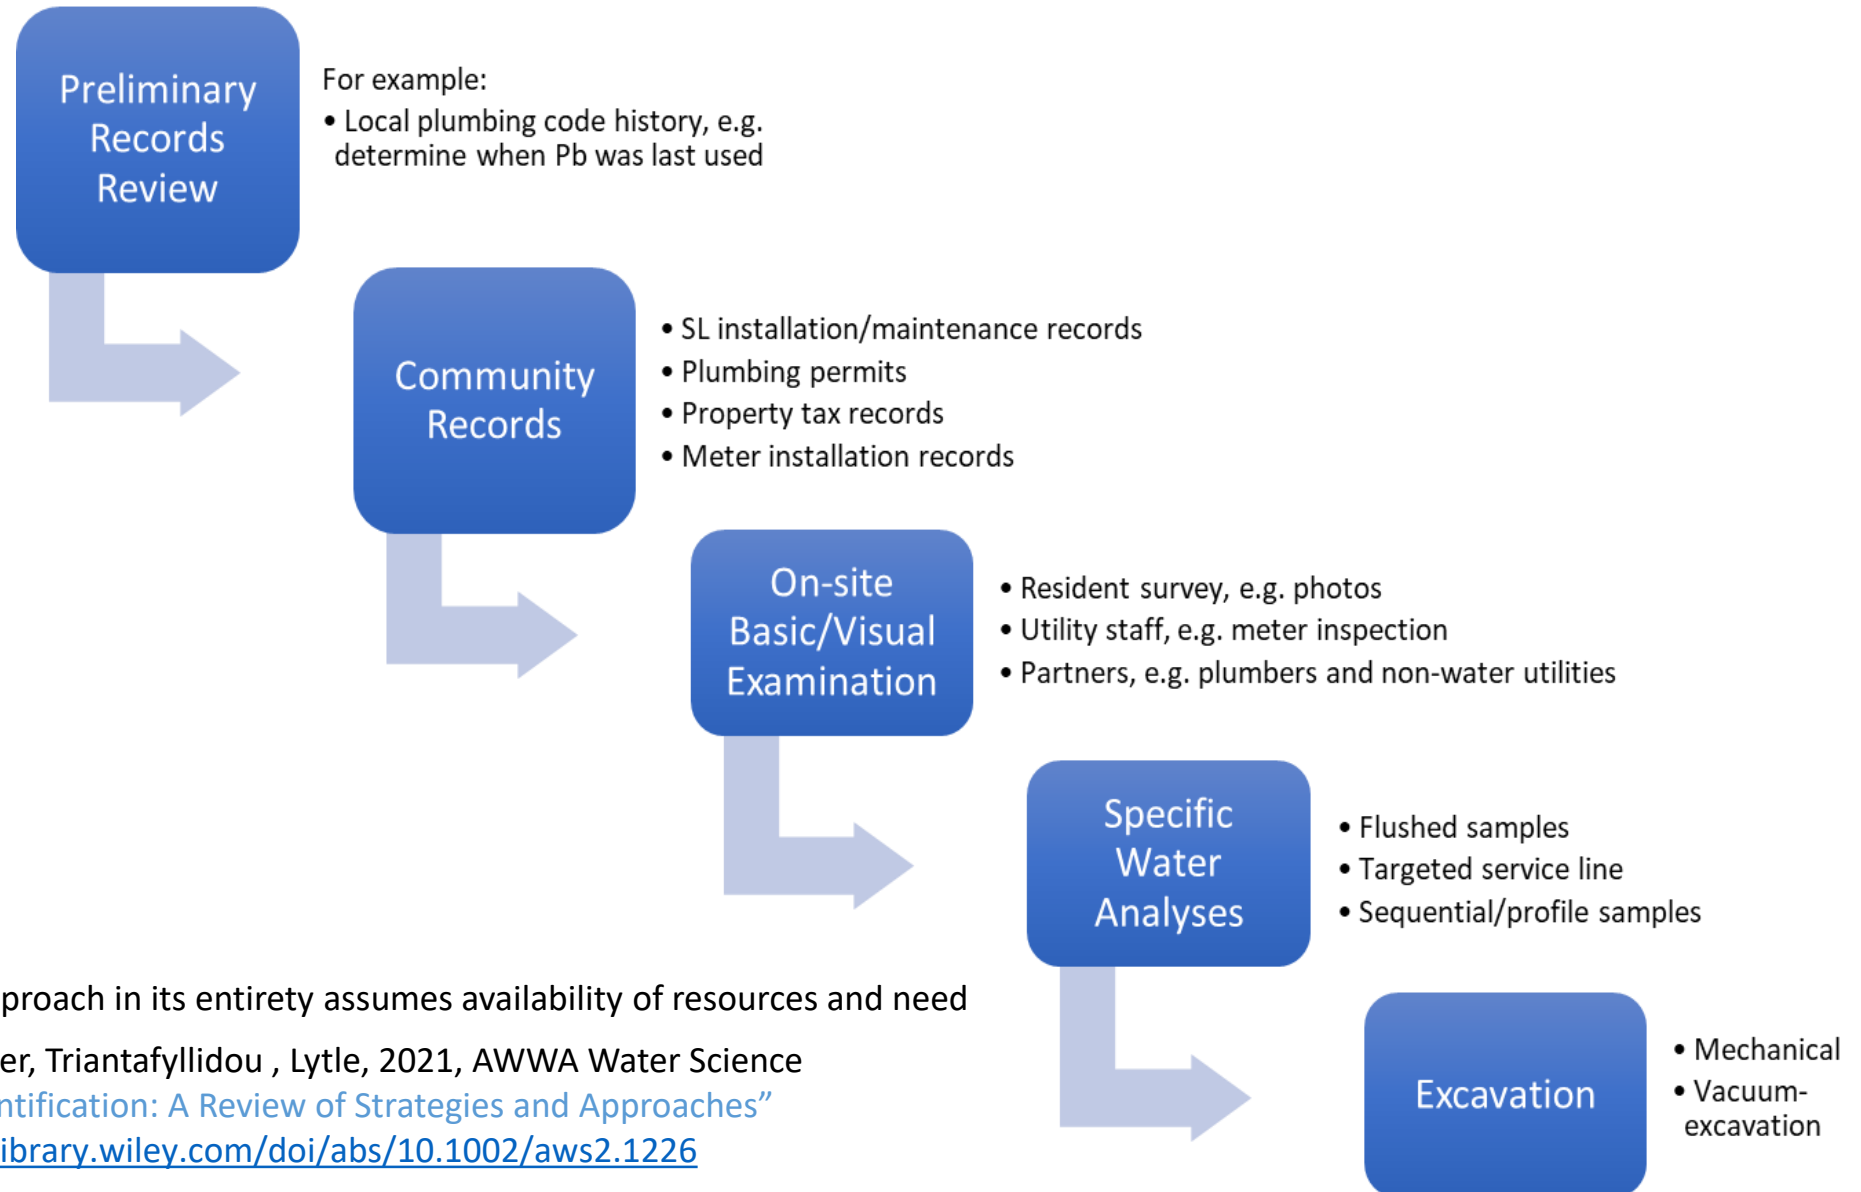
# Suggested stepwise SL identification approach

Note: Adopting the approach in its entirety assumes availability of resources and need

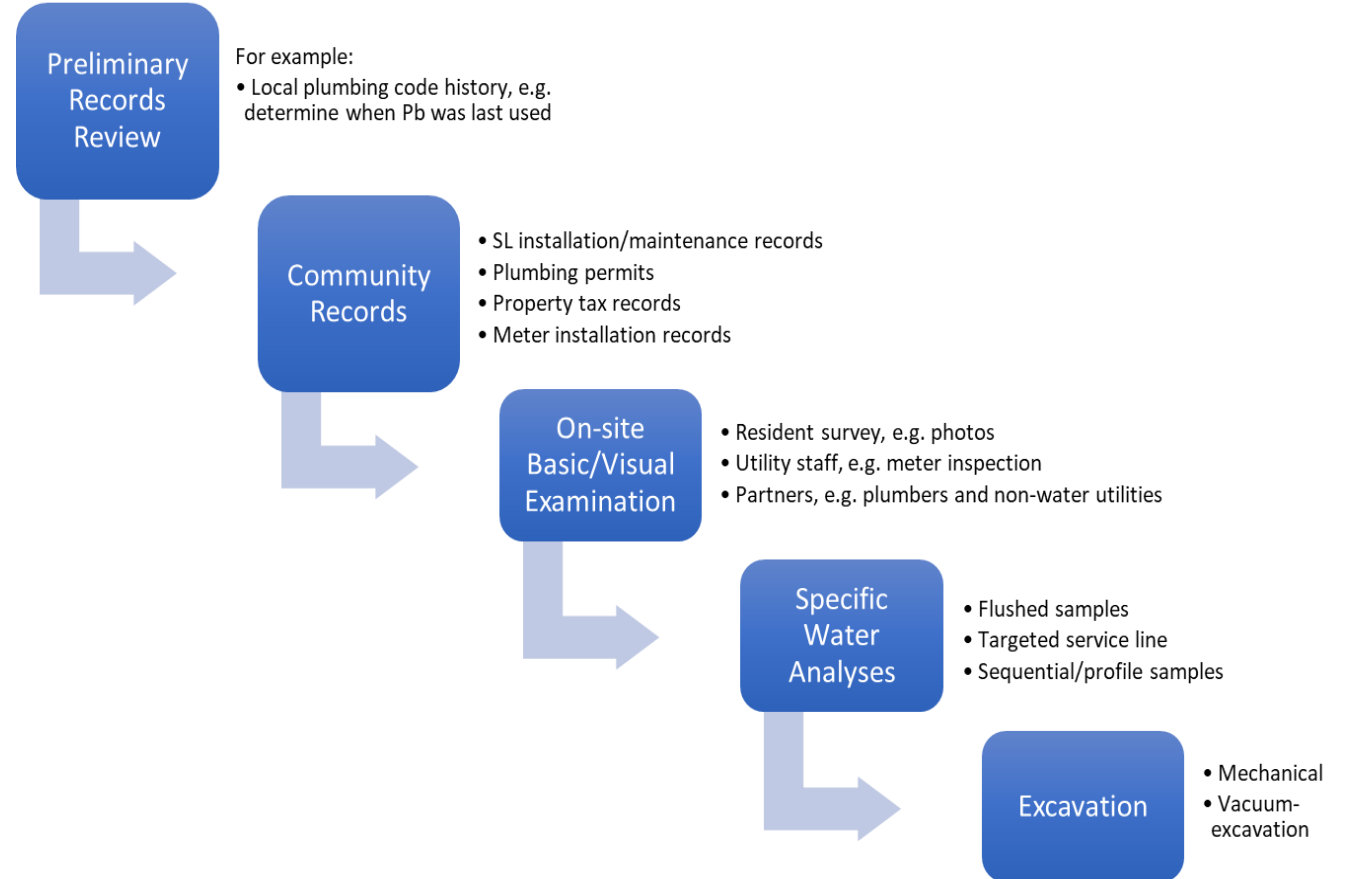
## Step-wise service line identification approach

Adopting the approach in its entirety assumes availability of resources and need  
<https://awwa.onlinelibrary.wiley.com/doi/abs/10.1002/aws2.1226>

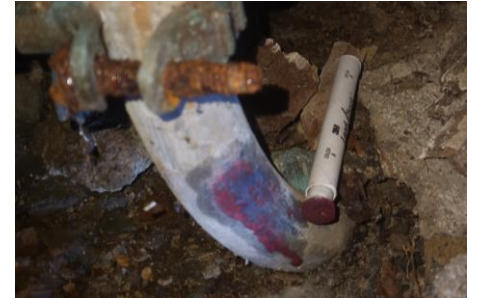
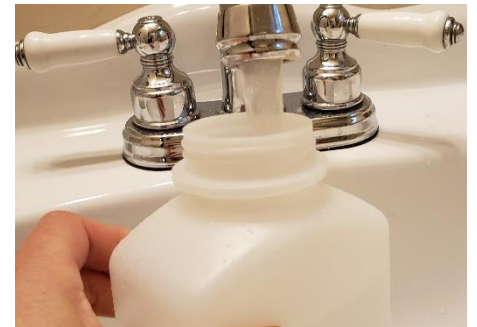
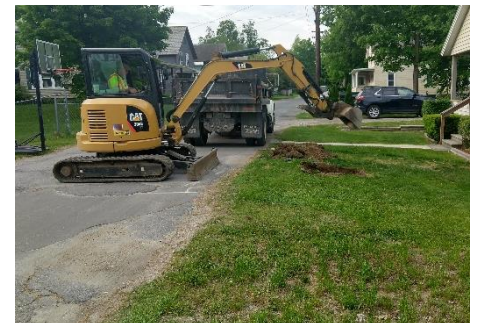
# Does the stepwise approach fit? Town in VT

- Basement inspections (paused during COVID):
  - Observe SL material entering foundation
  - Swab test when visual material observation was inconclusive
- 700 basement inspections proved records unreliable:
  - No lead at 71% of homes listed as LSLs
  - Lead at 14 % of homes listed as non-lead
