# The Use of Electrical Resistance Testing to Accurately Locate Buried Lead Water Service Lines and Other Pipe Materials Commonly Found in Drinking Water Pipes

Chuck Hansen<sup>1</sup>, Mike App<sup>2</sup>, Charles Wilmut, P.E.<sup>3</sup>, Bansari Doshi<sup>4</sup>, and Matt Campos<sup>5</sup>

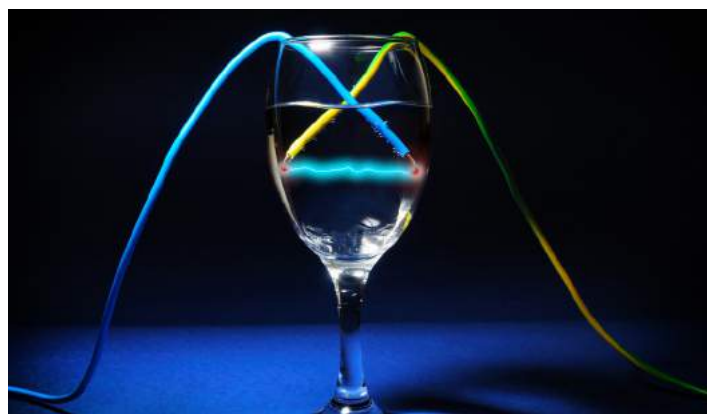
Figure 8. Using Water as a Conductor

The science of using low voltage conductivity is straightforward as shown in Figure 8, where two ends of the same circuit are able to use water as the conductor to still complete a circuit; often referred to as Focused Electrode Leak Location (FELL).

Most pipe materials such as brick, clay, plastic, concrete, and resin-based liners, are poor conductors of electrical current. As a result, if a defect exists in the wall of a pipe, leakage of electrical current will indicate the location and size of the defect. The measured intensity and duration of the electrical signal emanating from the pipe can be correlated to a flow rate in GPM, whether or not water infiltration or exfiltration actually occurs during the survey. Pipe wall corrosion and thickness can also be measured.

An approach was developed by establishing a (low) 12-volt electrical circuit with a 40 milliamp (mA) signal, using water as a conductor. This allowed two ends of the circuit to connect and close the loop, as depicted in Figure 9. Applied to an underground pipe, one side of the circuit would remain inside a non-conductive pipe (e.g., asbestos cement, brick, epoxy-coated ductile iron, high density polyethylene, plastic, resin-based liner, vitrified clay pipe, etc.). Connected to a grounding stake, any defect current would need to travel to the surface to confirm a corresponding pipe wall defect or leak.

If the loop remains ‘open,’ whereby changes in resistivity is flat or unchanged, the pipe would have no defects. Conversely, if the loop is ‘closed,’ whereby an electrical connection is made, then a leak or defect undeniably exists in the pipe wall, allowing a pathway from inside of the pipe to ground.

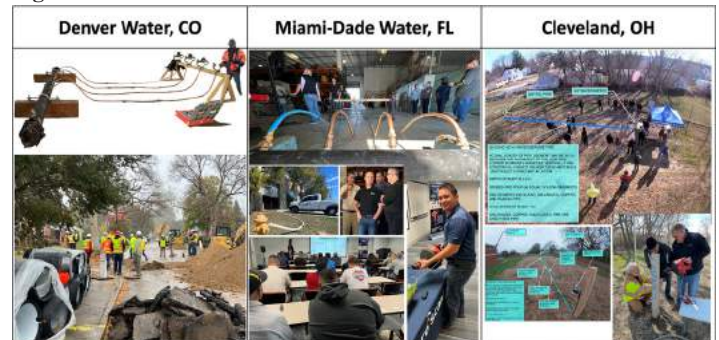
Figure 25. SWORDFISH Benchmark Evaluations

A key factor in SWORDFISH’s success has been its numerous field tests by some of the nation’s largest and smallest utilities. Both aboveground and below ground tests, as illustrated in Figure 25, demonstrated how SWORDFISH can navigate the most challenging underground pipe material changes, in many cases, not known by the utility.

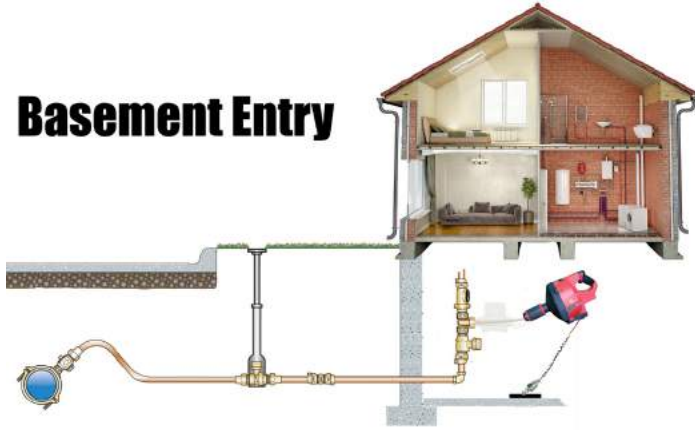
Figure 26. A Typical Basement Entry for SWORDFISH Survey.

Generally, two valves make it easier for a city's water department to change out the meter, if needed. As shown in Figure 26, once pressures are measured, valves can be shut off so meters can be temporarily removed to allow SWORDFISH insertion.
