IKT Product Test "Short Liner for House Connections": They also cause serious damage.

In February 2019, Roland Waniek, IKT's Managing Director, met with Chuck Hansen, CEO, & Mike App, VP, Electro Scan Inc. to discuss results using Focused Electrode Leak Location (FELL) testing to provide rapid assessment of CIPP Short-Liners.

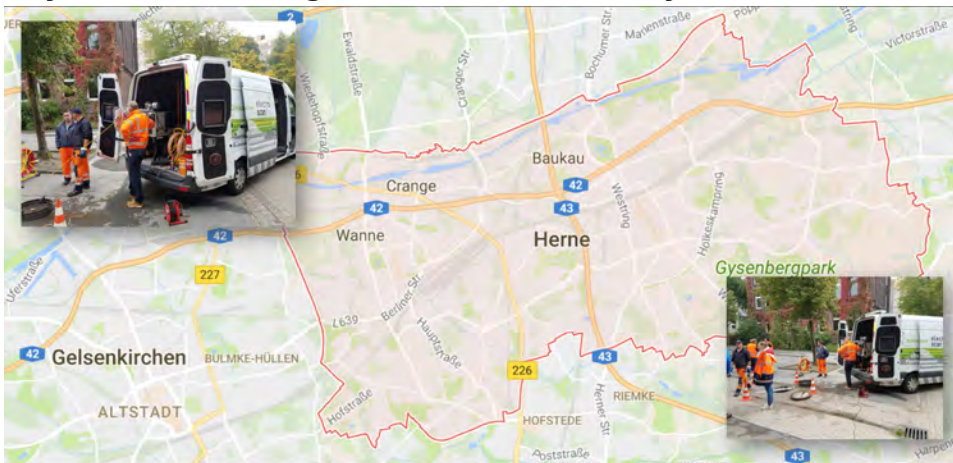
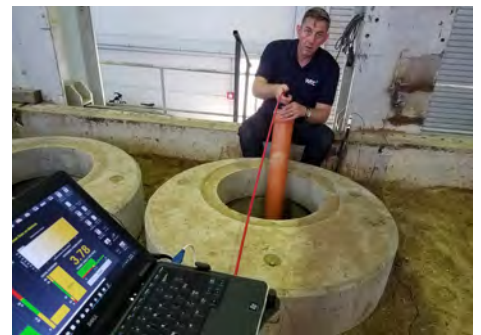
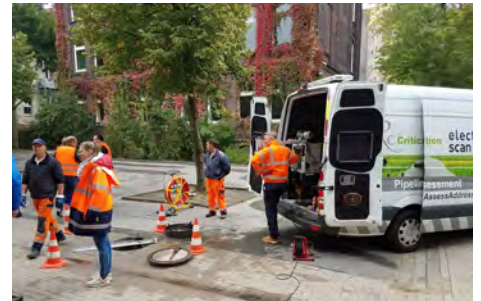
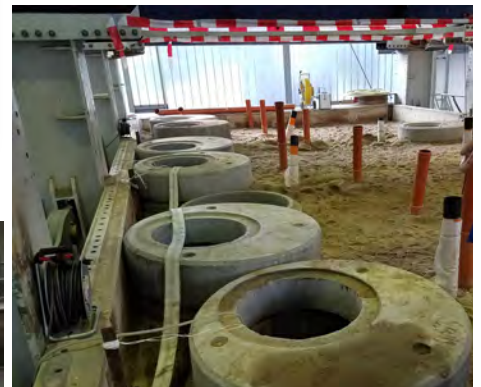
Day 1 - Field Investigations, Herne, Germany

In September 2017, under contract to British-based WRC plc & American-based Electro Scan Inc. two-days of assessments were completed for both in-field & laboratory testing of lateral short liners confirming post-rehabilitation defects missed by closed-circuit television cameras could be identified using Focused Electrode Leak Location (FELL).
