New Standards for Testing and Certifying Cured-In-Place Pipe

By Chuck Hansen, BSc, MBA, Founder Electro Scan Inc., Former Chair ASTM F36.20, Former Chairman & Founder Hansen Software Inc. (1983-2007).

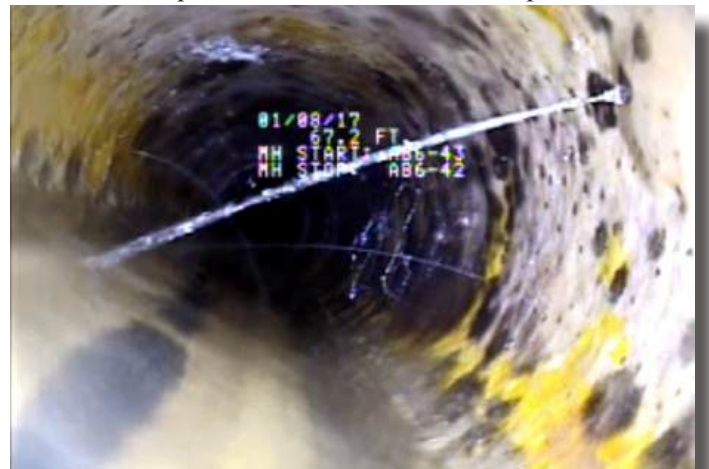
Figure 1. Cured-In-Place Pipe lining installed in 2014 by a national lining contractor, approved by CCTV inspection in 2014, in accordance with ASTM F1216 (See Table 1). FELL inspection in 2017 located nineteen (19) measured defects and over 100 pinhole leaks and is now recommended to certify all CIPP liners as leak free, prior to acceptance.

“After selling Hansen Software in 2007, I got a call from Ken Kerri¹ asking me to look for ways to find & measure defects in CIPP liners, missed by CCTV (Figure 1).

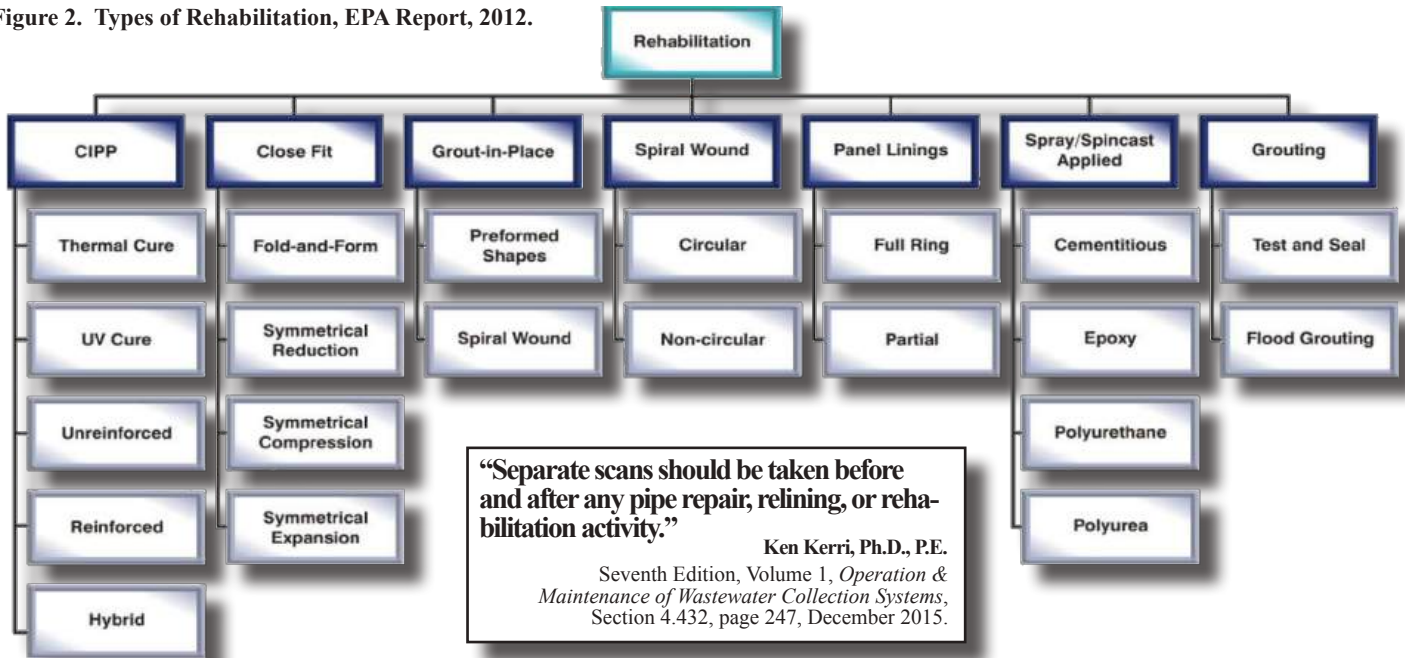
Figure 2. Types of Rehabilitation, EPA Report, 2012.

In January 2012, the US EPA published *A Retrospective Evaluation of Cured-in-Place Pipe (CIPP) Used in Municipal Gravity Sewers* (Figures 2, 4, and 5). As part of the study, independent testing of CIPP was conducted in both large and small diameter sewers in two cities: Denver, CO and Columbus, OH.

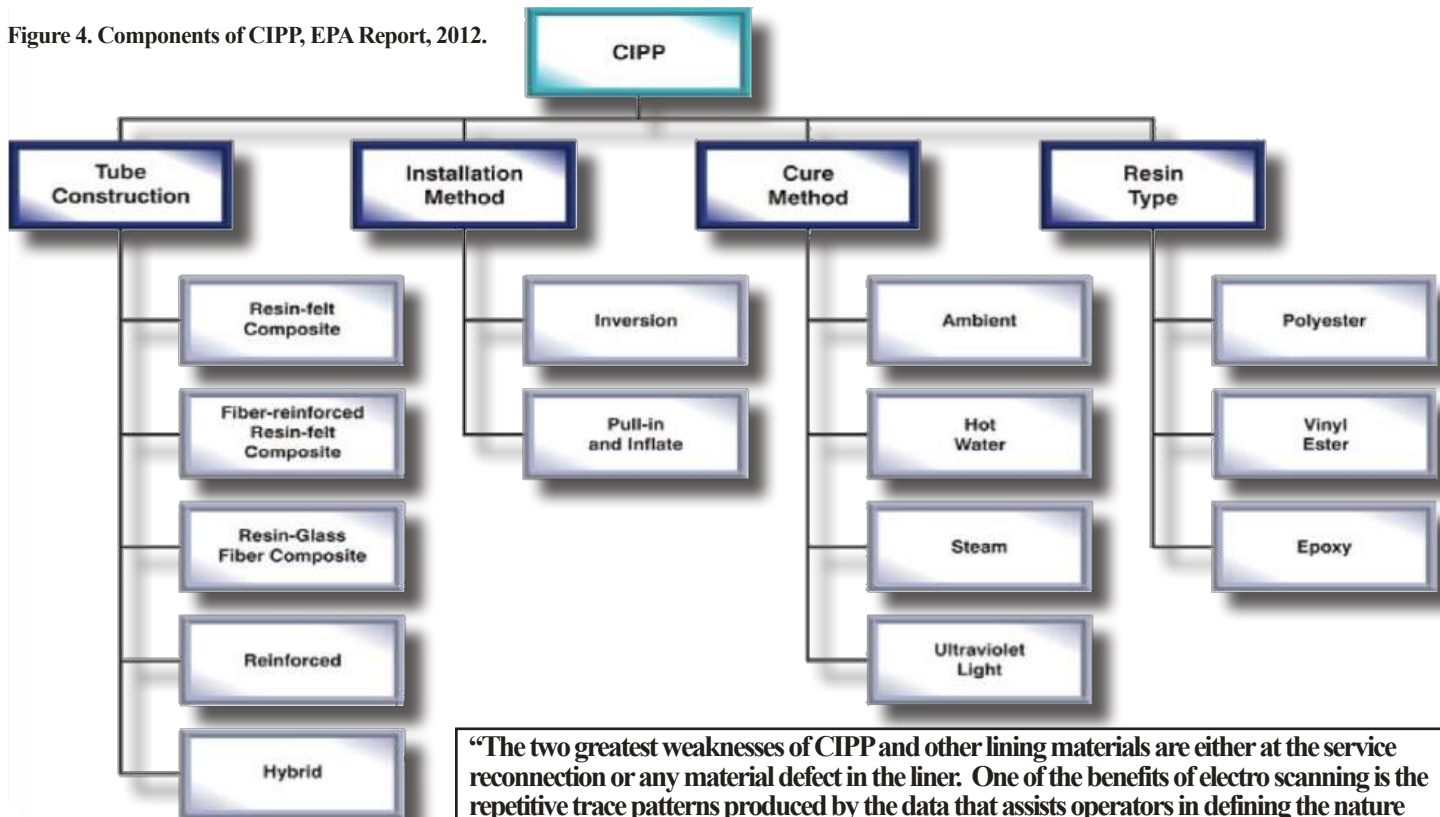
Figure 4. Components of CIPP, EPA Report, 2012.

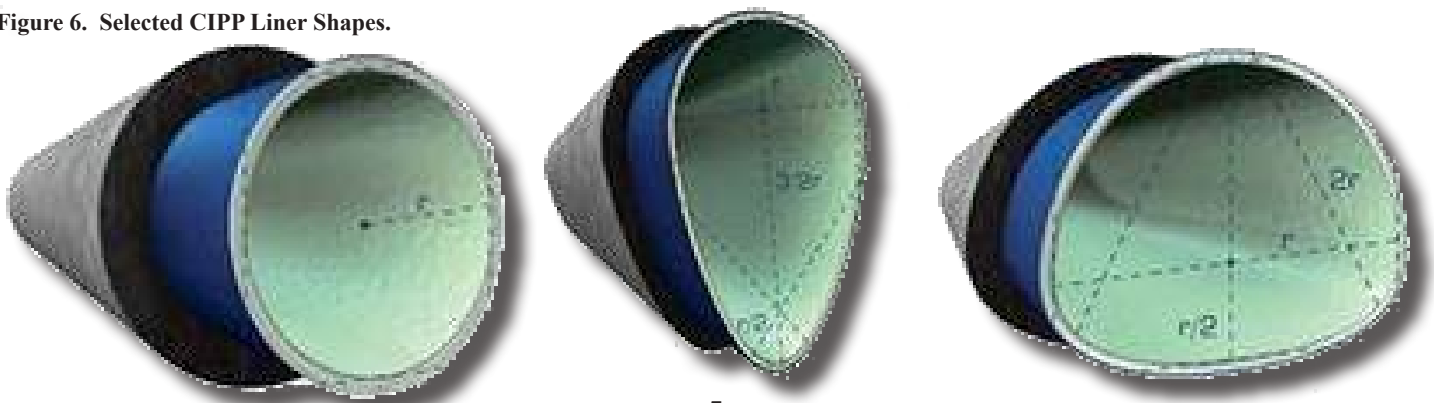
Figure 6. Selected CIPP Liner Shapes.

Given their industry experience and pioneering computer applications, principals of the new company created a sophisticated cloud-based reporting system, allowing data to be wirelessly uploaded to servers located around the globe. With over 10,000 data points for every 300 ft (100 m) of scanned pipe, final reports are generally available within ten minutes after completing a survey. Each report identifying specific locations and severity of defect in gpm or lps for all diameters and shapes (Figure 6).

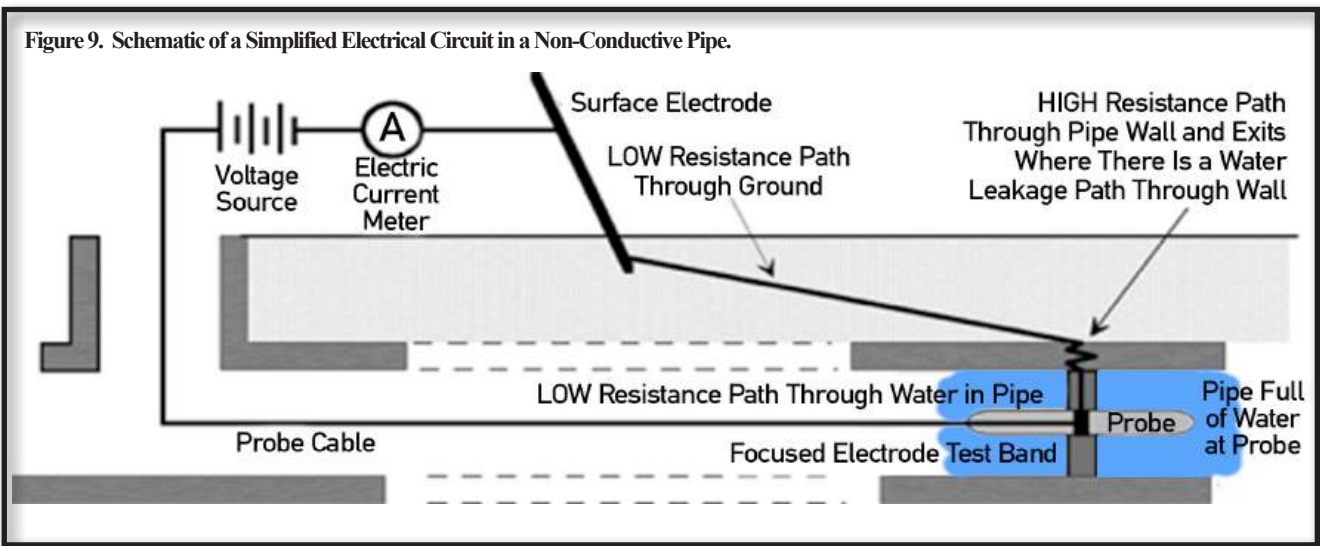
ASTM F2550-13, Section 8.5.1

“It is recommended that separate scanning tests be taken before and after any pipe repair, relining, or renewal activity to compare electrode current values, and for closed-circuit television (CCTV) video to re-examine pipes to determine if any visual defects were missed or not recorded during initial examination.”

In November 2013, the American Society for Testing and Materials International (ASTM International) ratified and published ASTM F2550-13 *Standard Practice for Locating Leaks in Sewer Pipes By Measuring the Variation of Electric Current Flow Through the Pipe Wall* (Figures 8, 9, and 10).

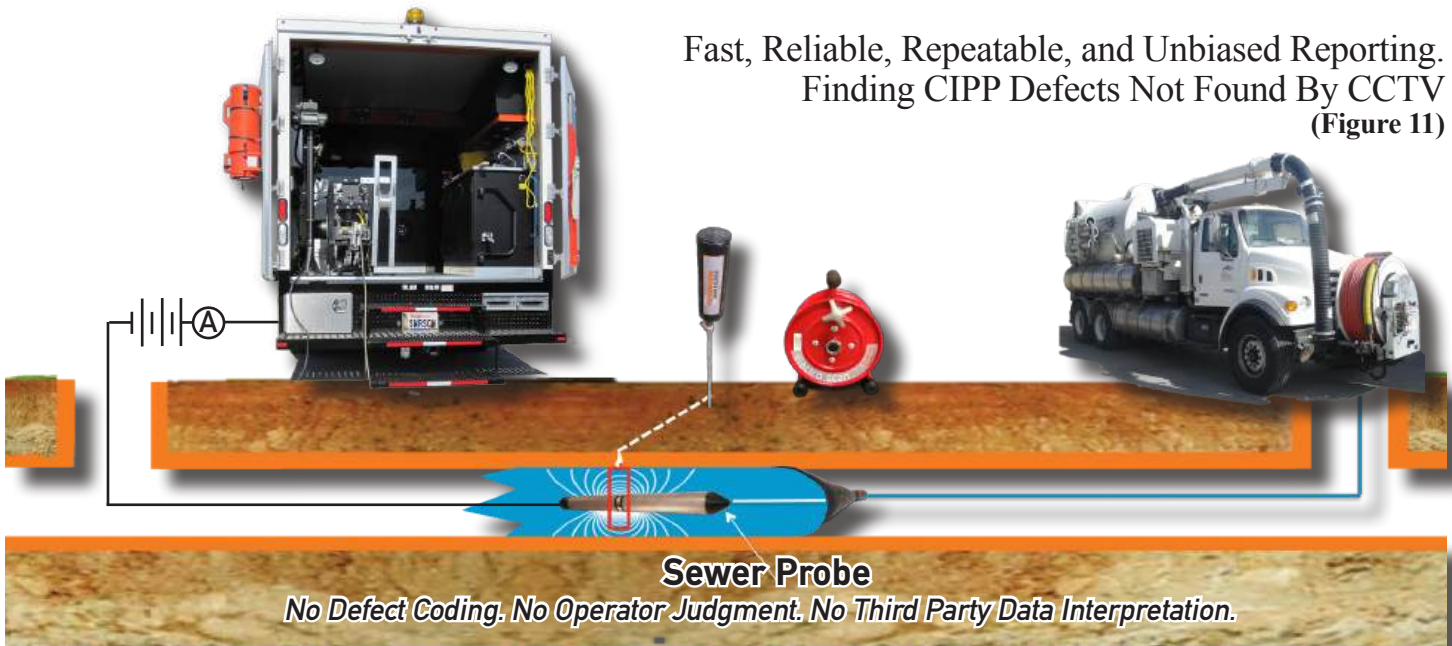
Figure 10. Actual Field Set-Up for Assessing Pre- and Post-Rehabilitated Sewer Mains.

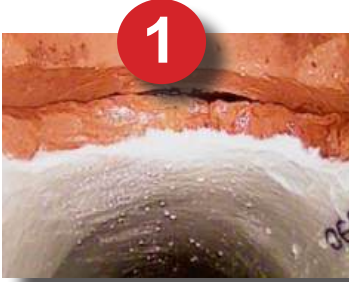
1. Post-CIPP, Bad Invert Connection

CIPP Defects Not Found, Recorded, or Measured By CCTV

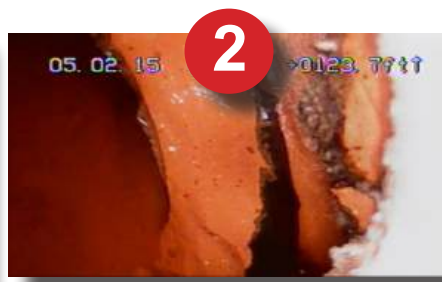
2. Post-CIPP, Bad Service Reconnection

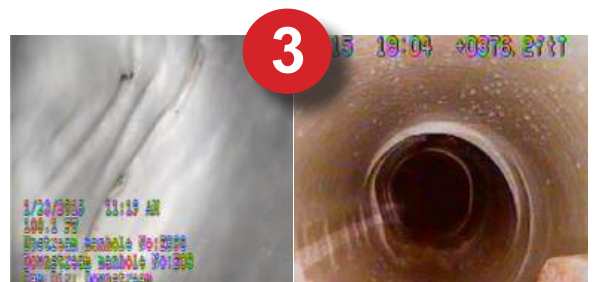
3. Wrinkles.

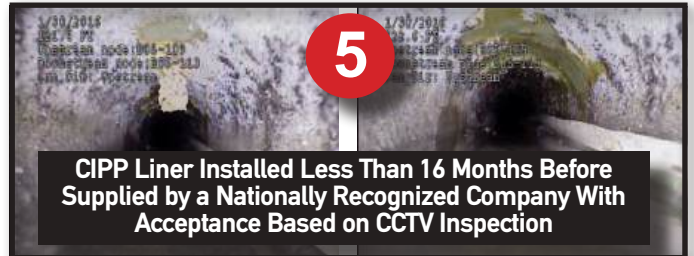
5. Bad Resin. Installed less than 16 months prior.

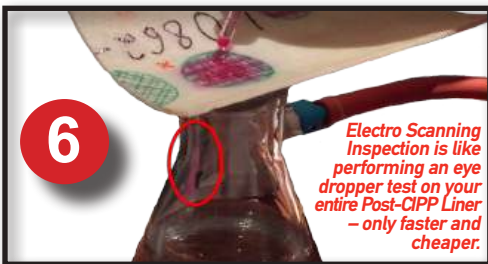
6. Defective/Weak Liner

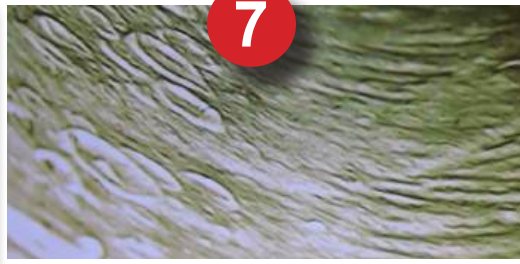
7. Overcooked Liner

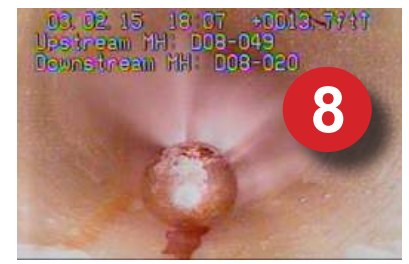
8. Unreported Contractor Damage

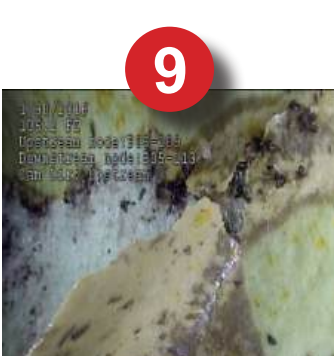
9. Defective Epoxy

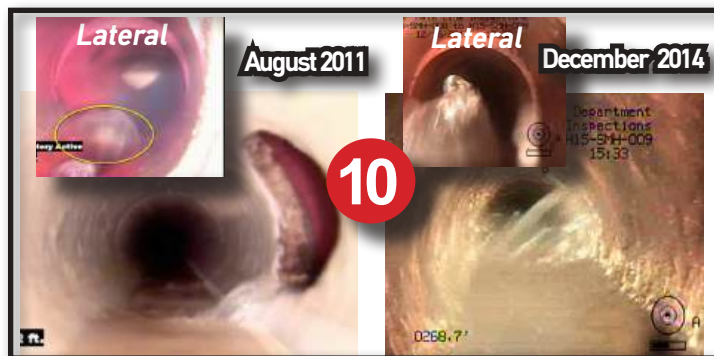
10. Misreported Bad Reconnection. Same Leak Running 4 Years.

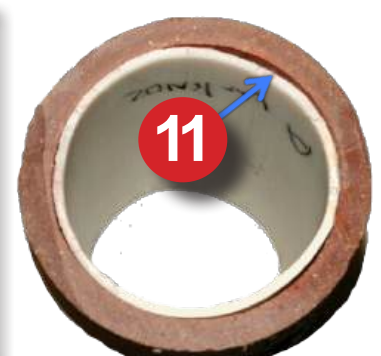
11. Annular Space

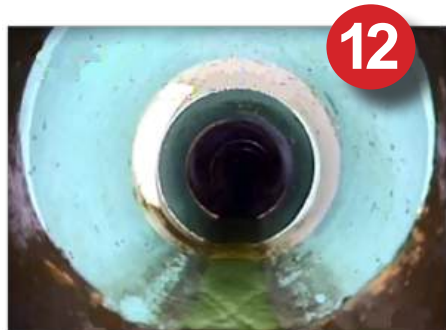
12. Bad Sectional Spot Repair

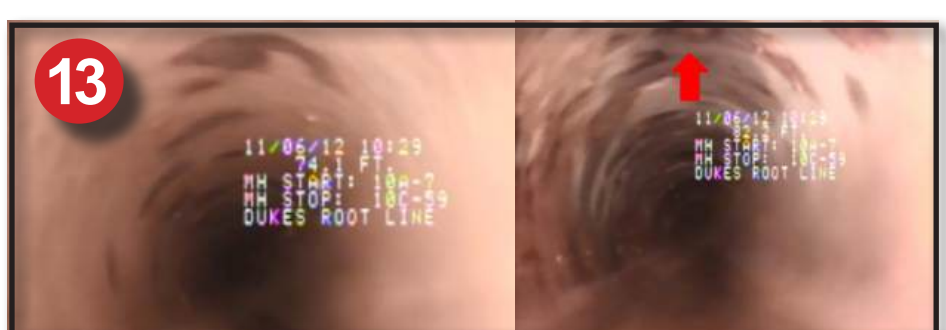
13. Infiltration Spotting

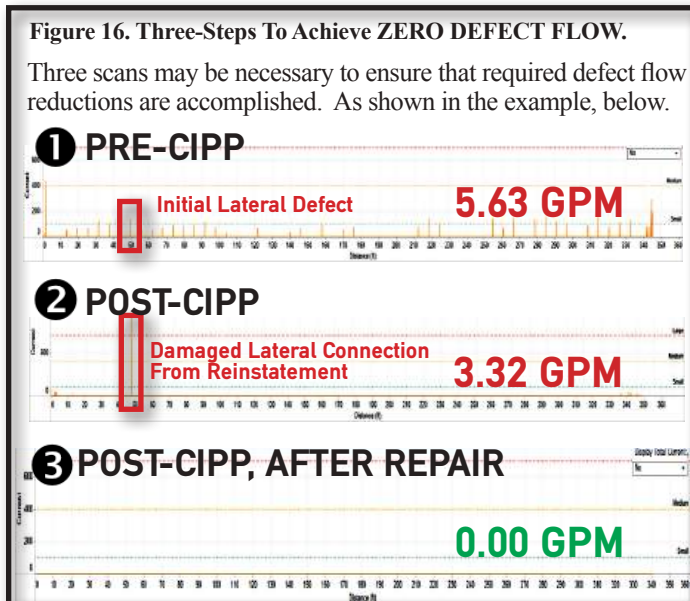
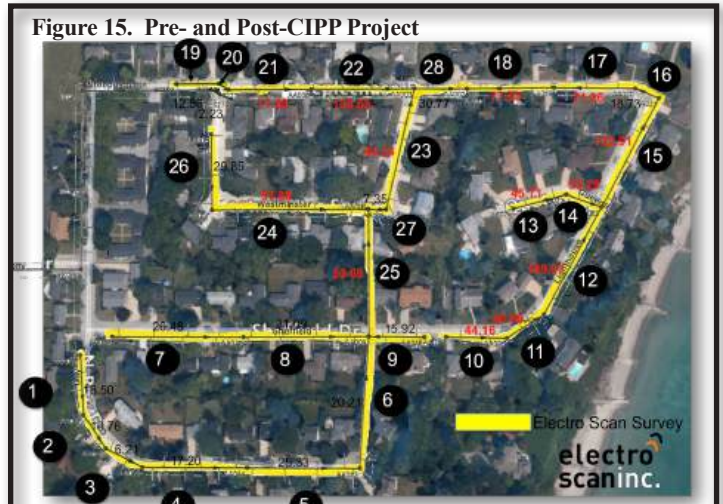
The Goal: Manage Rehabilitation to ZERO GPM (Figure 16).

Pre-Rehabilitation 1,708,171 GPD
Total Feet: 5,559 | Total Segments: 28

How is it possible for CIPP liners to have higher defect flows after rehabilitation compared to before rehabilitation? Simple. Mechanical cleaning of pipes prior to lining may cause damage not present before lining. Root cutting and removal may exacerbate this. Also, remote tap cutting of service laterals that under-shoot or over-shoot the lateral, may cause large defects.

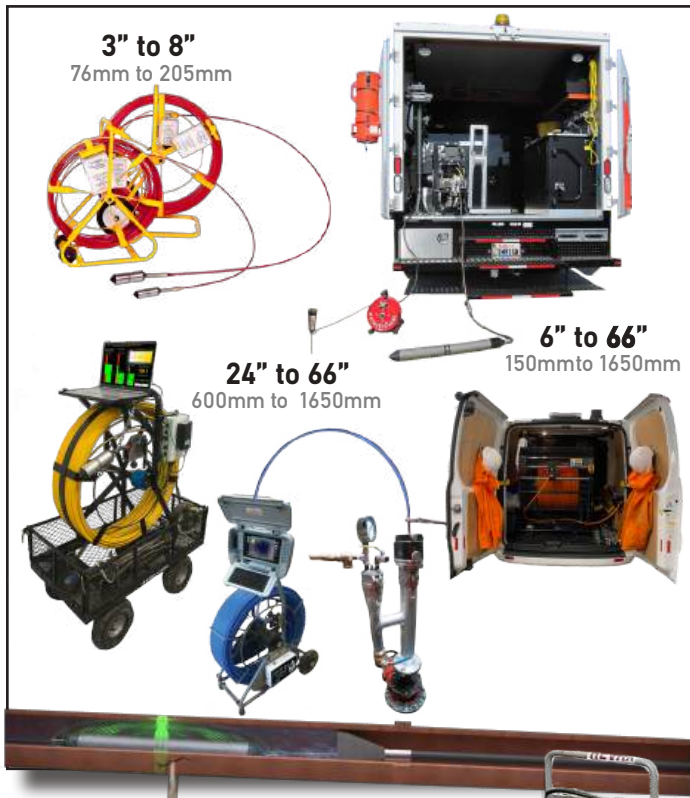
Figure 17. Electro Scan Probes for Sewer and Water

Available for purchase by municipal sewer agencies and utilities and available through authorized business partners, Electro Scan offers a wide range of devices matched to specific pipe diameters and rugged terrain, if required.
