# City of Houston, TX: Using CCTV to Recommend Sewer Rehabilitation (1990-2025)

## City of Houston, Texas, Use of CCTV for Condition Assessment 1990-2025

# First AI Decision Support Tool to Use CCTV Visual Inspections to Recommend Rehabilitation

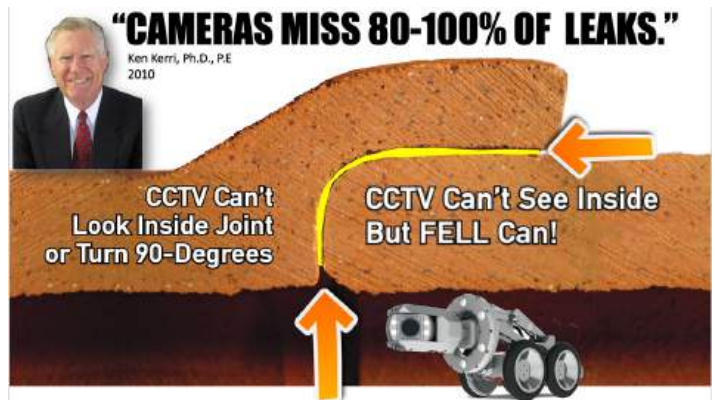
(Below) Henry Gregory reviews CCTV and FELL technologies on a failed West Coast CIPP lining project (2016).
